IMPOUNDMENT INSPECTION AND CERTIFIED REPORT		Clear Water Pond	
Permit Number	ACT/007/035	Report Date 12/28/01	
Mine Name	SUNNYSIDE REFUSE AND SLURRY		
Company Name	SUNNYSIDE COGENERATION ASSOCIATES		
Impoundment Identification	Impoundment Name	Clear Water Pond	
	Impoundment Number	004	
	UPDES Permit Number	UT 024759	
	MSHA ID Number	N/A	
IMPOUNDMENT INSPECTION			
Inspection Date	12/13/01		
Inspected By	Scott Carlson		
Reason for Inspection (Annual, Quarterly or Other Periodic Inspection, Critical Installation, or Completion of Construction)		Fourth Quarter Inspection 2001	
<p>1. Describe any appearance of any instability, structural weakness, or any other hazardous condition.</p> <p>NONE</p>			
<p>Required for an impoundment which functions as a SEDIMENTATION POND.</p>	<p>2. Sediment storage capacity, including elevation of 60% and 100% sediment storage volumes, and, estimated average elevation of existing sediment.</p> <p>Storage Capacity = 4.9 acre-feet Maximum Sediment Depth Elevation = 6527 Existing Sediment Elevation = 6523+-</p>

RE: Fourth Quarter 2001 Inspection Report

Please find enclosed a copy of the Fourth Quarter 2001 Inspection Report for Sunnyside Cogeneration Assoc

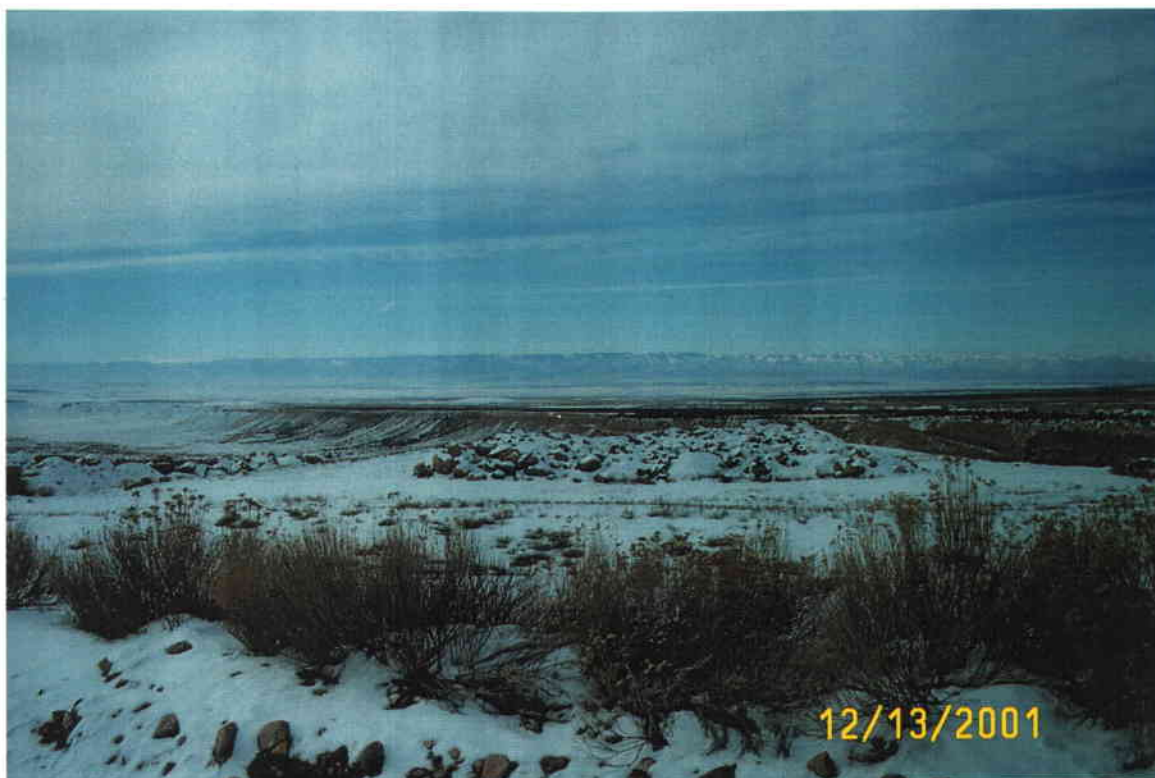
Excess Spoil Disposal Area #1 looking West/Northwest

No evidence exists of fires in the pile.

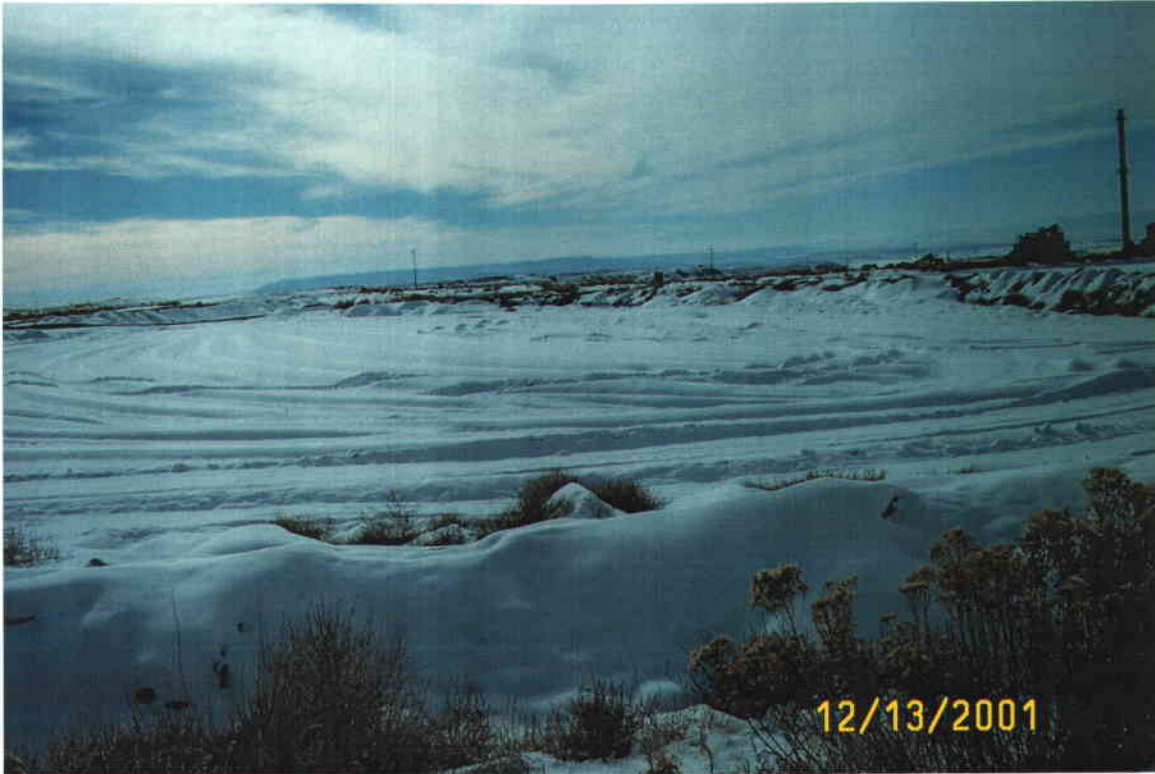
Excess Spoil Disposal Area #2

North portion looking south

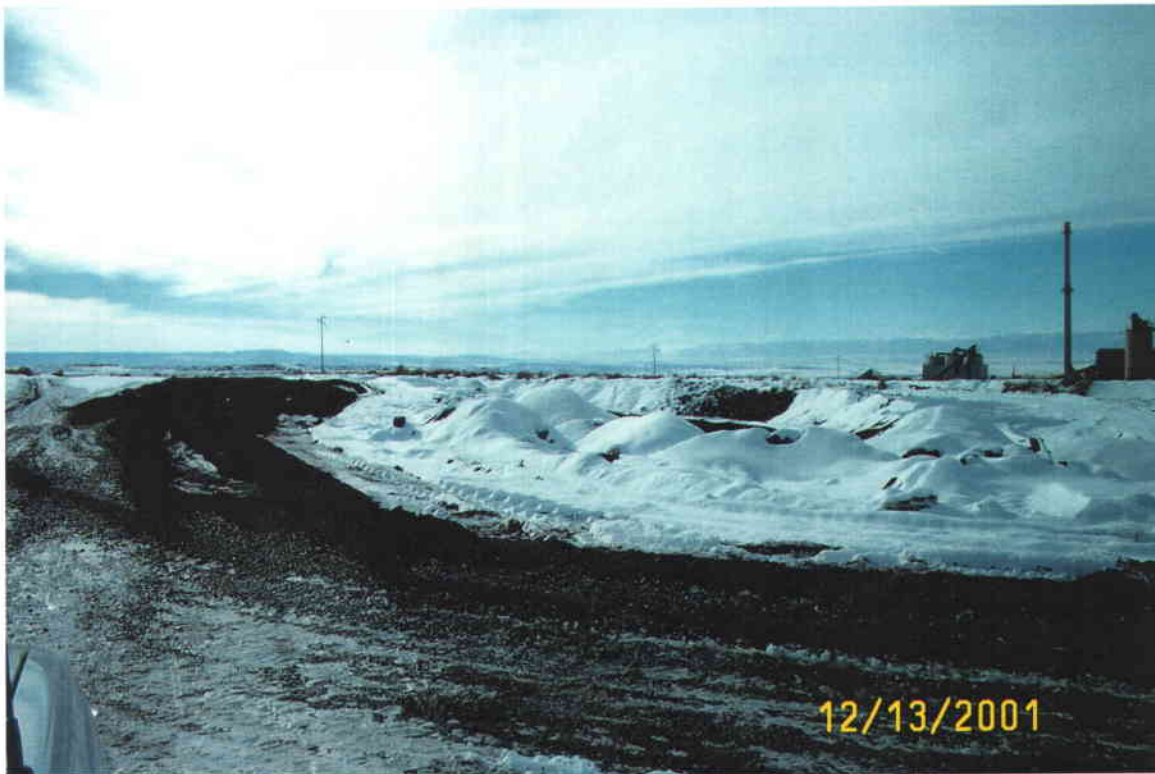
Excess Spoil Disposal Area #2

South portion looking south
